16 house Quench Dec, 5, 2003

Dean Still
Fermilab Tevatron Department
12/12/2003

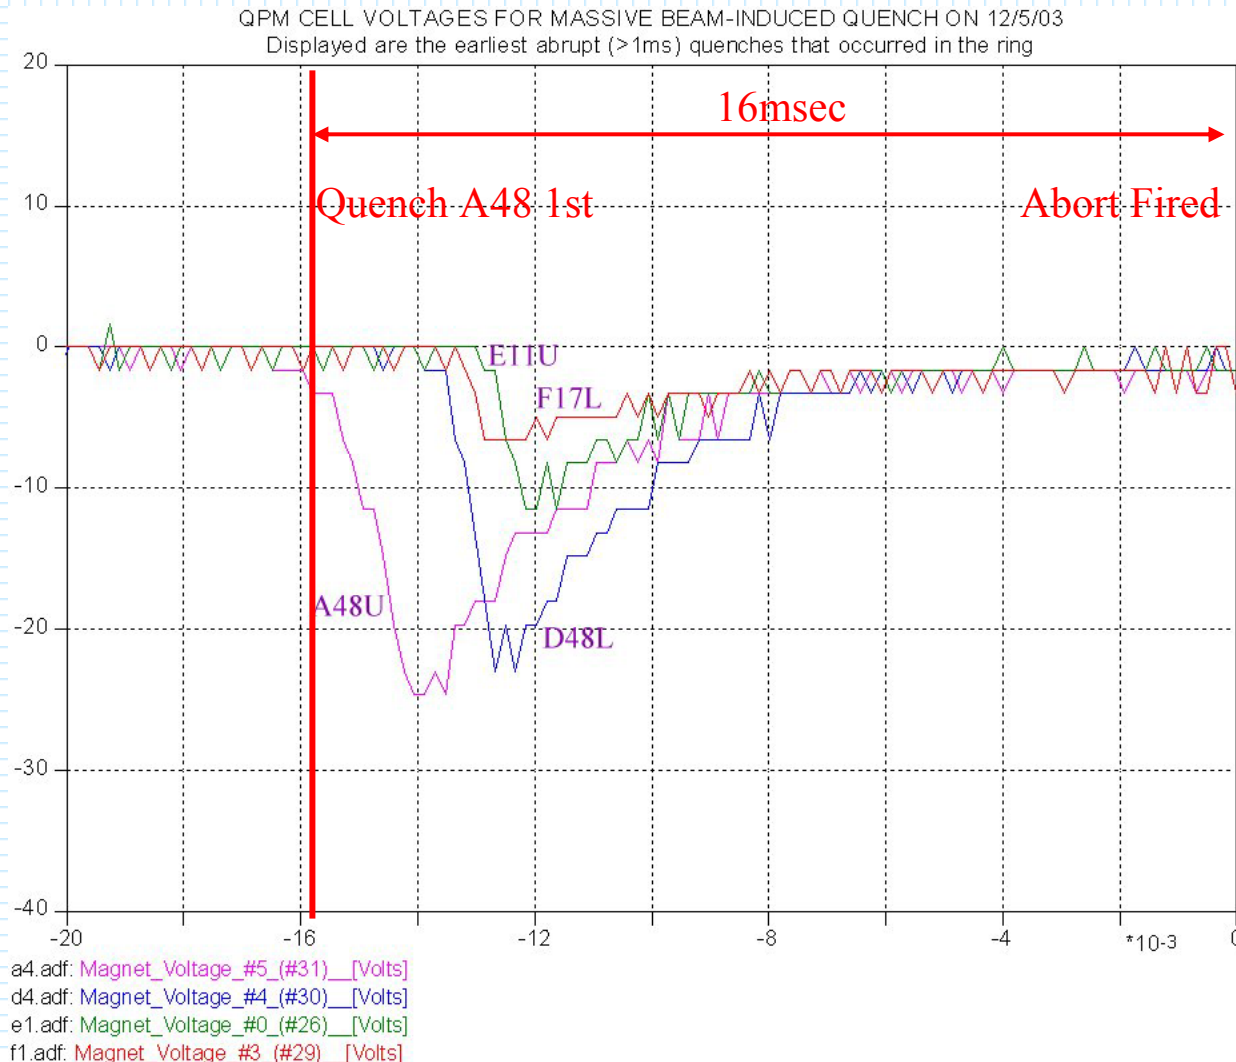
QPM Over Sample Buffer

Development of Quench:

A48U 16msec
D48L 13.5msec
F17L 13msec
E11U 12.5 msec

Before abort

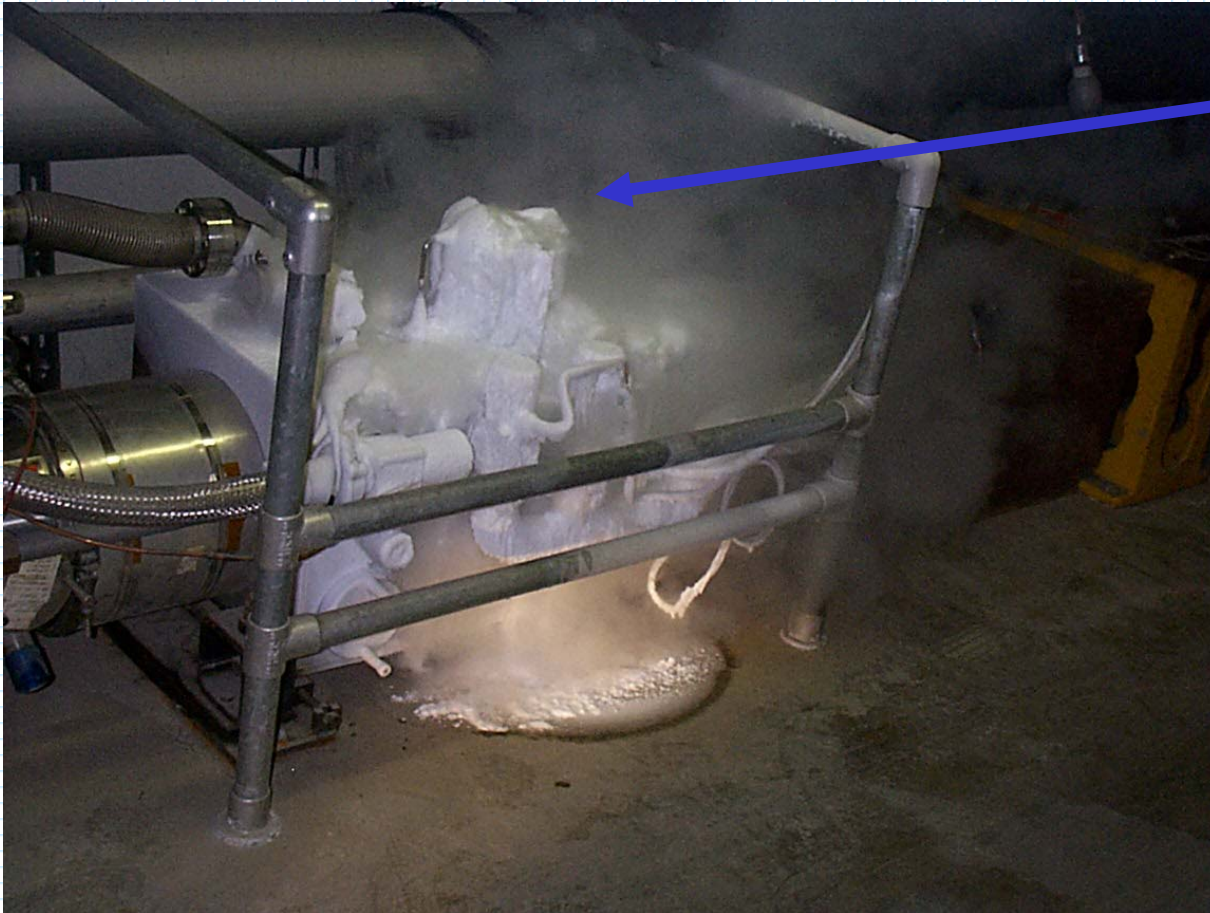
Result of quench at C19.

Conning tower
correction
element damage
requiring C1
to be warmed to
room temp
for repair.
